Annual Technical Summary Meeting
2016 RI/FS Summary
Leviathan Mine Site, Alpine County, California
January 26, 2017

2016 Remedial Investigation Activities (On-Property, DSA, and SSAs)

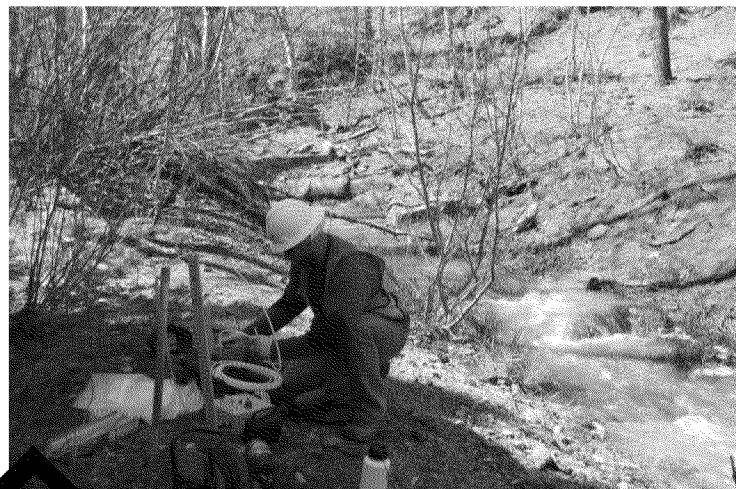
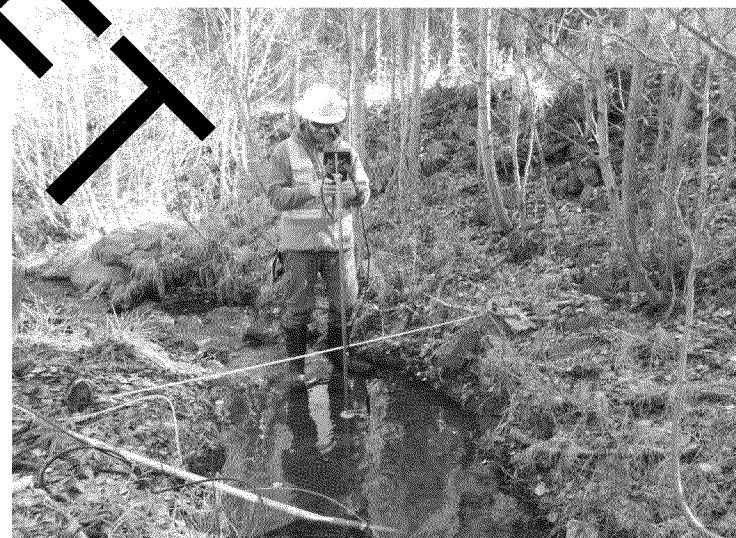
CUD and Aspen Seep Flow Station Data Collection & Maintenance

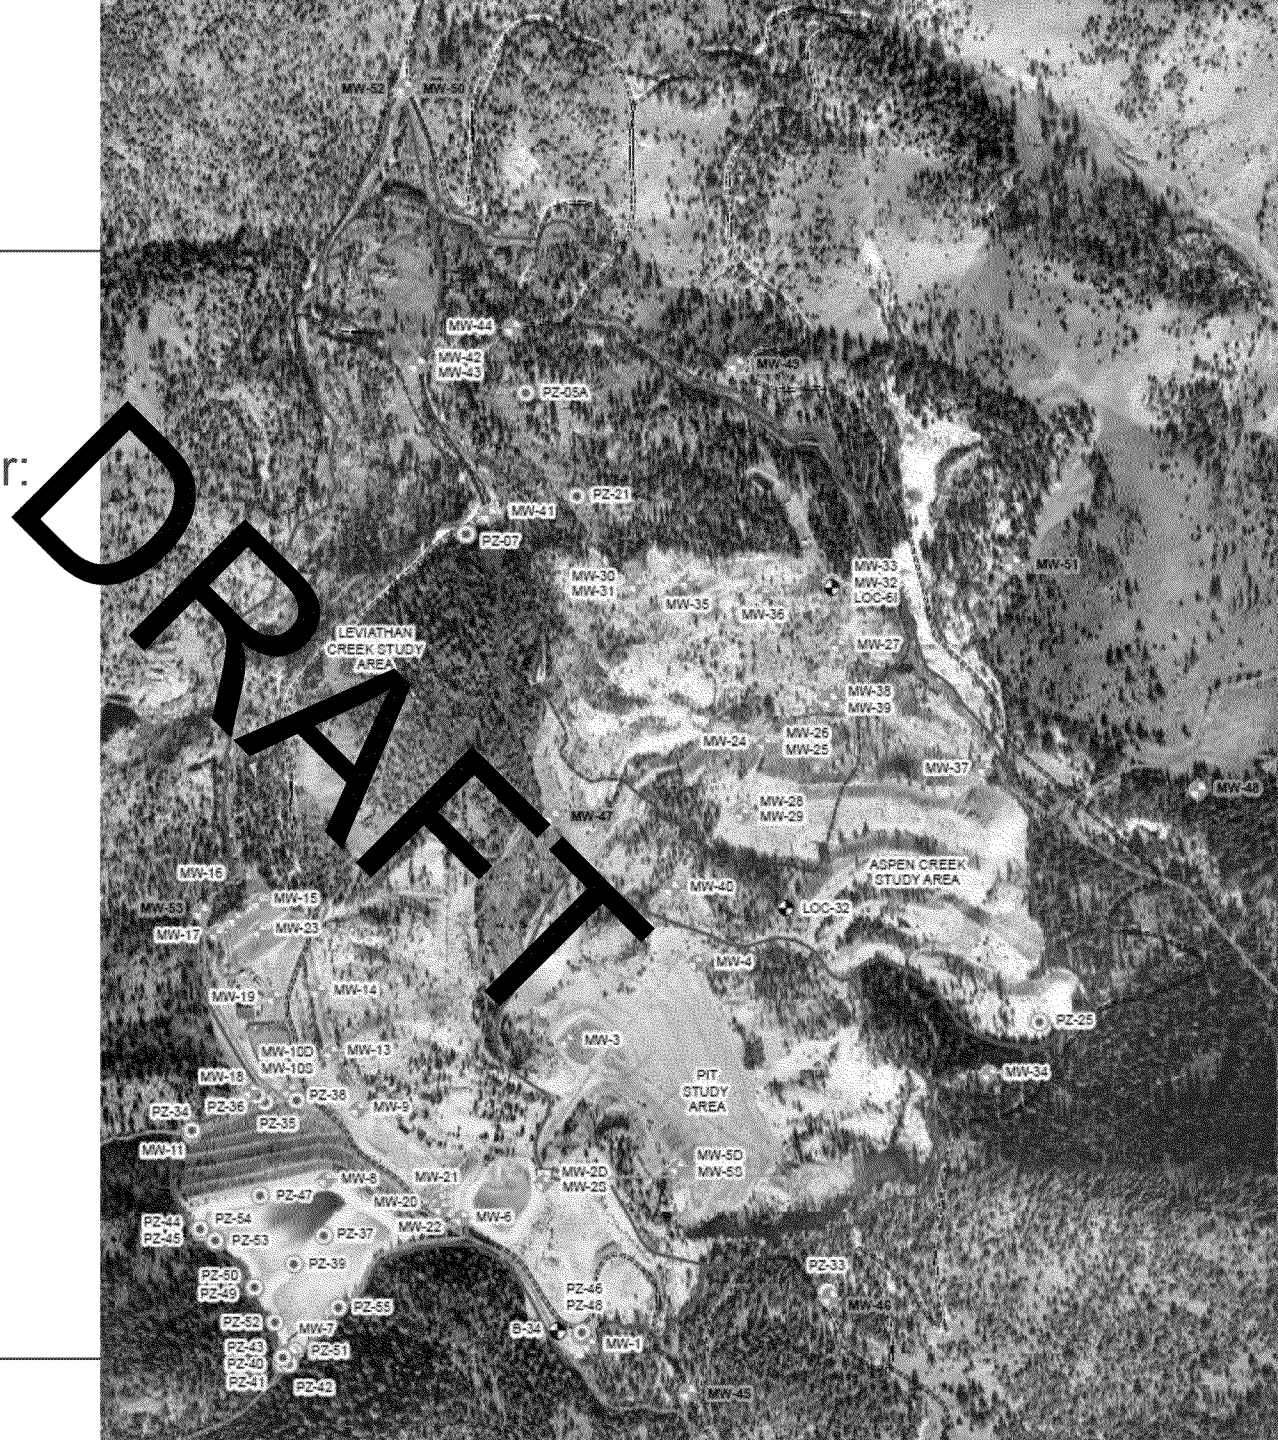
2016 Monitoring Well Installation

- ▶ LOC-37 (MW-51)
- ▶ LOC-38D (MW-50)
- ▶ LOC-38S (MW-52)
- ▶ LOC-39S (MW-49)
- ▶ LOC-40S (MW-48)
- ▶ LOC-41 (MW-53)

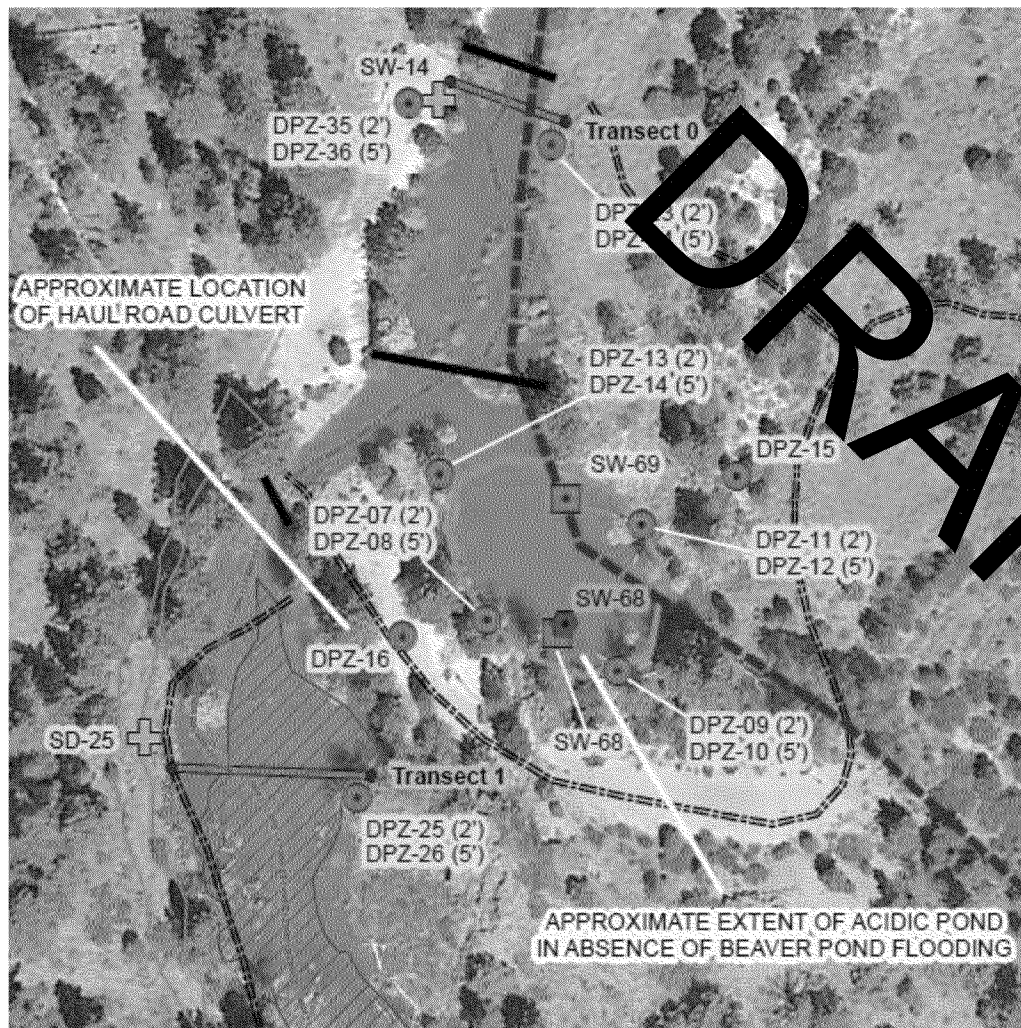
Leviathan Creek/Acidic Pond Surface Water/Groundwater Interaction Investigation

- ▶ 36 Drive Point Piezometers (16 pairs + 4 singles)
- ▶ 9 water level transducers in select drive point piezometers
- ▶ 3 Surface Water Staff Gages and stilling wells
- ▶ 13 surface water monitoring locations
- ▶ 3 water level transducers in select surface water monitoring locations
- ▶ 3 Seepage Meeters

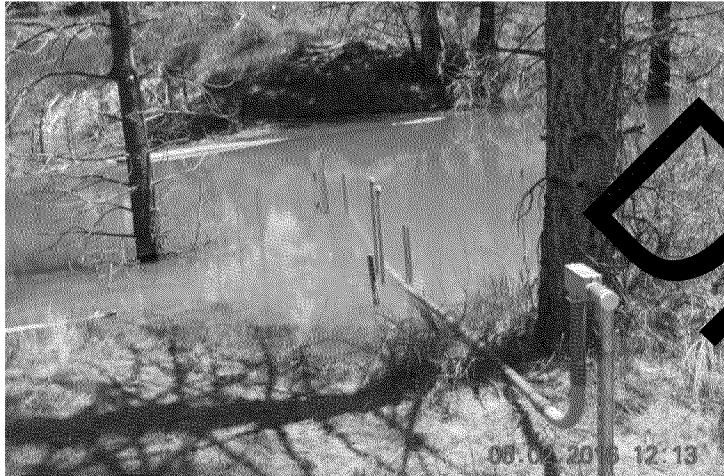
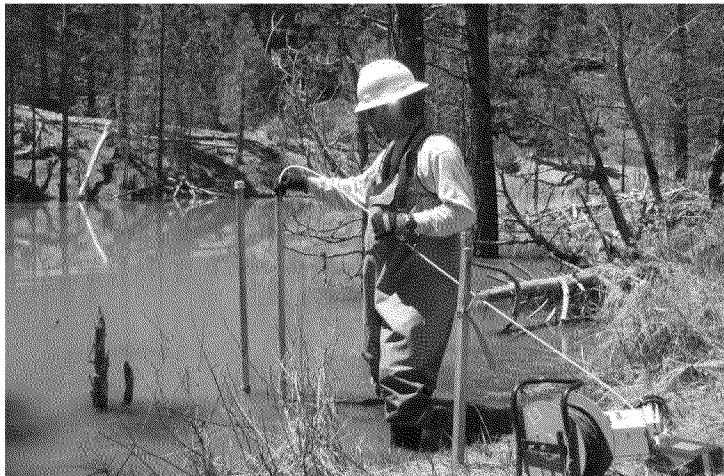
Surface Water/Groundwater Interaction Investigation (continued)

- ▶ Measured water levels in drive-point piezometers monthly
- ▶ Collected surface water samples and flow measurements at the surface water monitoring locations in spring and late summer when the beaver ponds were at their lowest water level
- ▶ Collected groundwater samples from the drive-point piezometers in spring and early fall when the beaver ponds were at their lowest water level

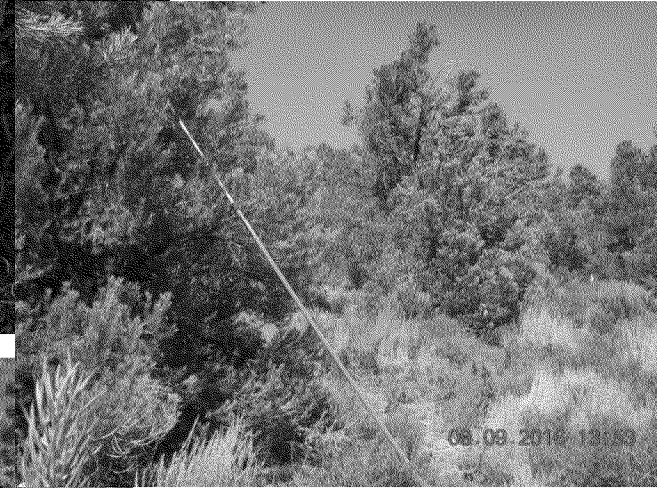
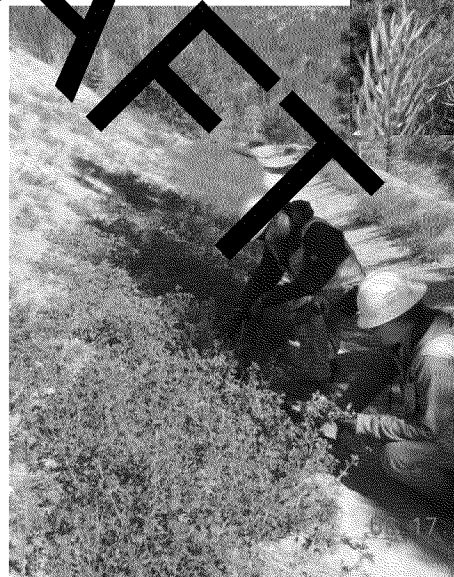
2016 Plant and Habitat-Related Soil Investigation

- ▶ On-Property
 - ▶ 23 locations
- ▶ Downstream Study Area
 - ▶ 36 locations
- ▶ Reference Study Area
 - ▶ 15 locations

- ▶ Targeted plant tissue (stems, seed, leaves, fruit, etc.)
- ▶ 64 plant tissue samples collected

- ▶ Collocated soil samples collected at two depths where possible
- ▶ 75 habitat-related soil samples

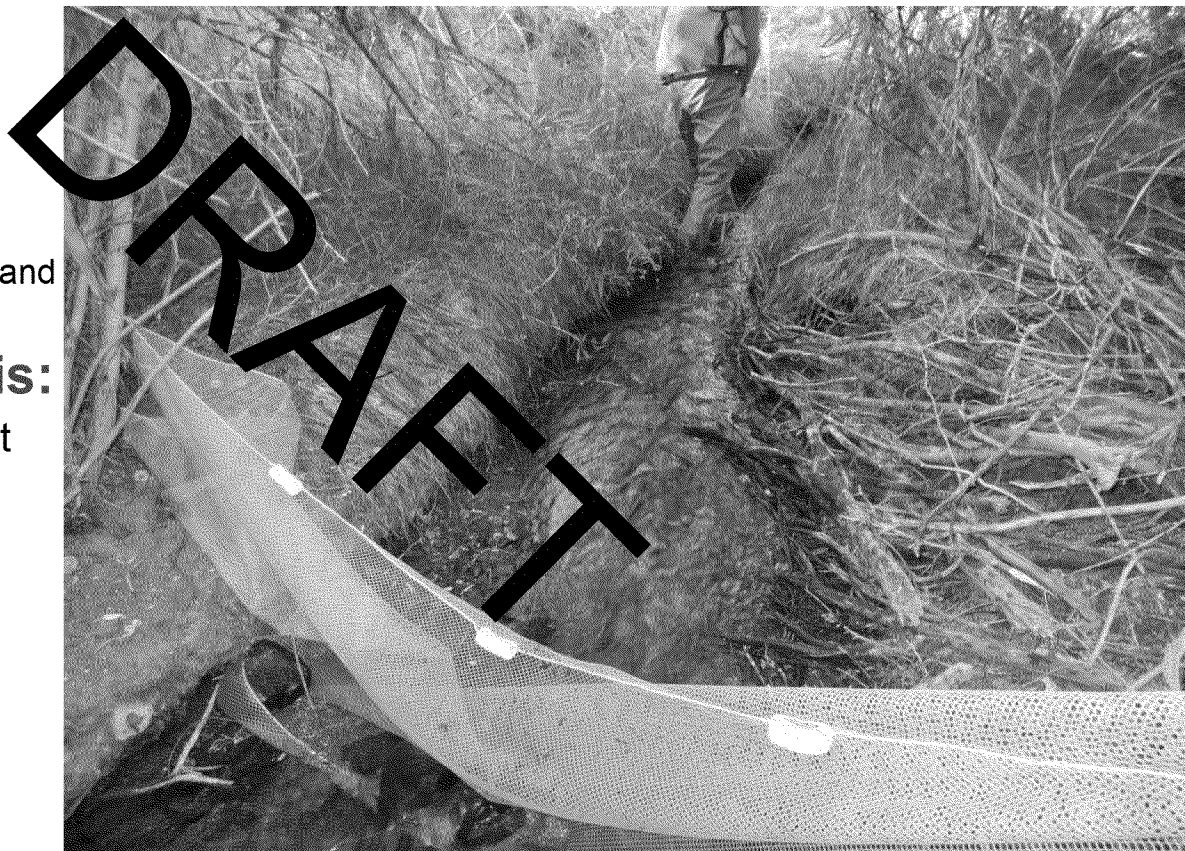
2016 Fish Survey and Sampling

- ▶ On-Property
 - ▶ 3 reaches
- ▶ Downstream Study Area
 - ▶ 12 reaches
- ▶ Reference Study Area
 - ▶ 9 reaches (3 in Cottonwood and 6 in Mountaineer Creek)

- ▶ On-Property: no fish present
- ▶ DSA: 36 individual and 13 composite fish samples
- ▶ RSA: 9 individual and 14 composite fish samples

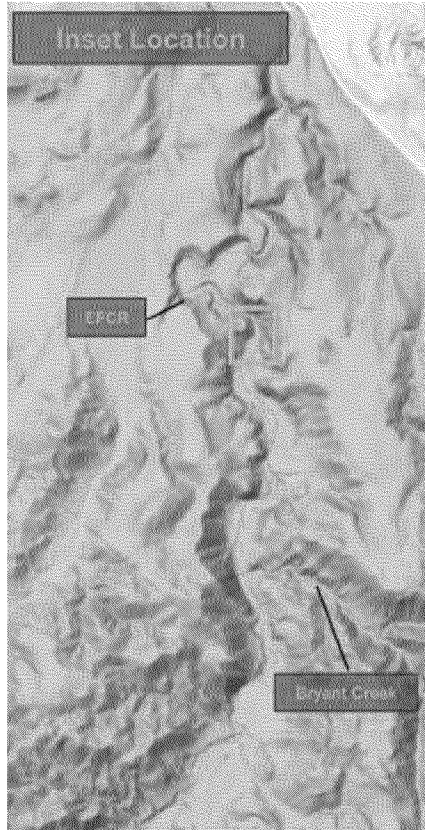
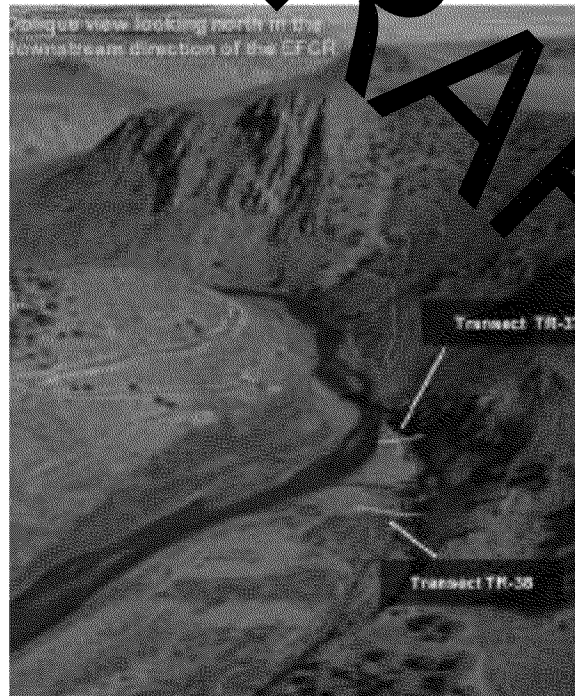
2016 East Fork Carson River Fluvial Soil and Surface Water Investigations

- ▶ 10 Transects
 - ▶ 5 Upstream of Bryant
 - ▶ 5 Downstream of Bryant
- ▶ 3 Locations in each Transect
- ▶ 8 Surface Water Locations
 - ▶ 4 Upstream of Bryant
 - ▶ 4 Downstream of Bryant

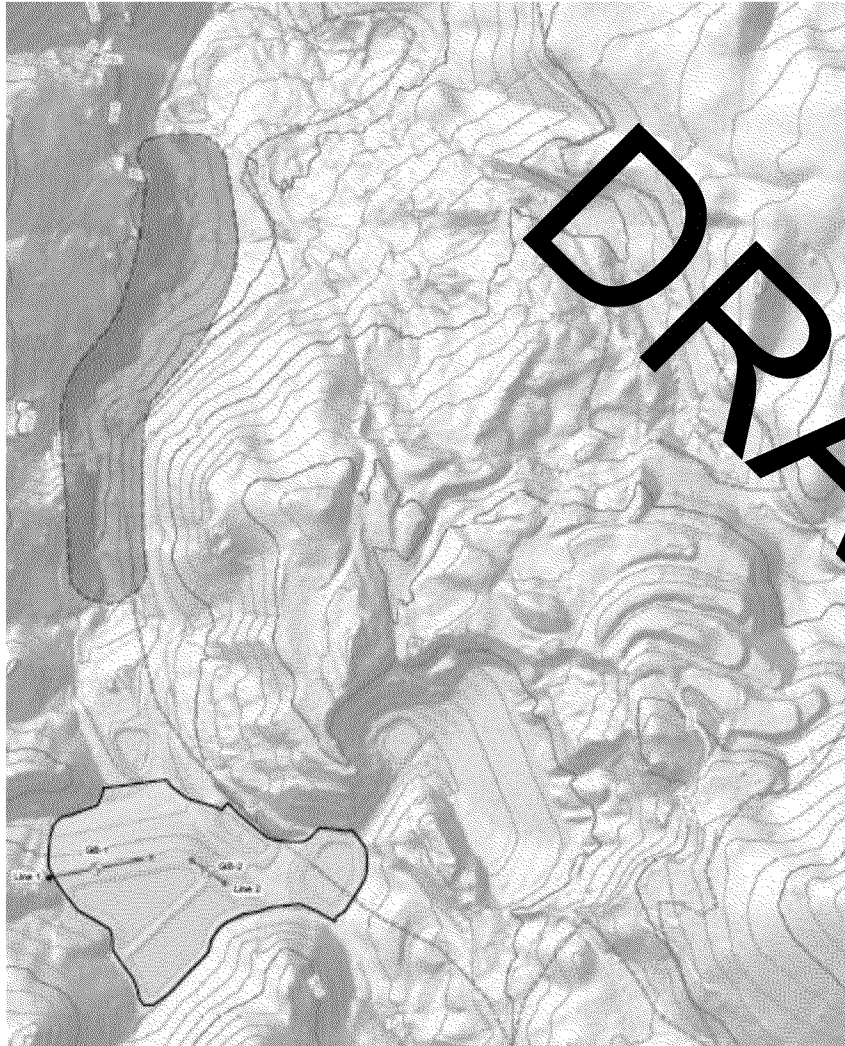
2016 Geotechnical Investigation

- ▶ Completed review of existing soil and rock core
- ▶ Conducted four geophysical surveys at two locations on mine waste near Pond 2N/2S
- ▶ Completed two geotechnical borings in mine waste near Pond 2N/2S
 - ▶ CB-1 to a depth of 61.5 feet
 - ▶ CB-2 to a depth of 133 feet
- ▶ Completed geotechnical/geologic mapping along Leviathan Creek between the Delta Area and the toe of the Leviathan Creek Basin Landslide

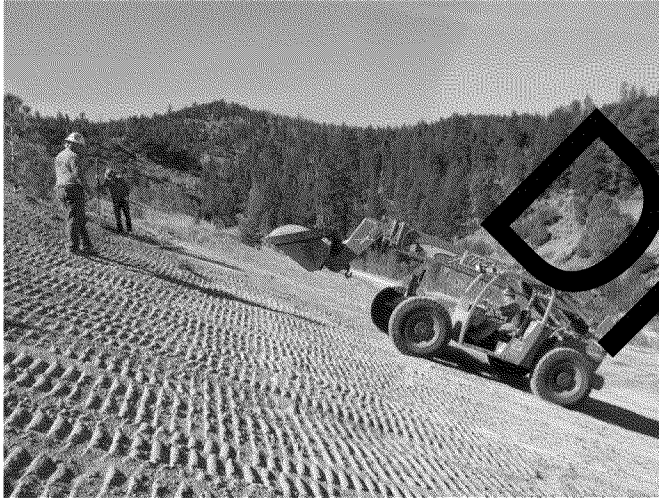
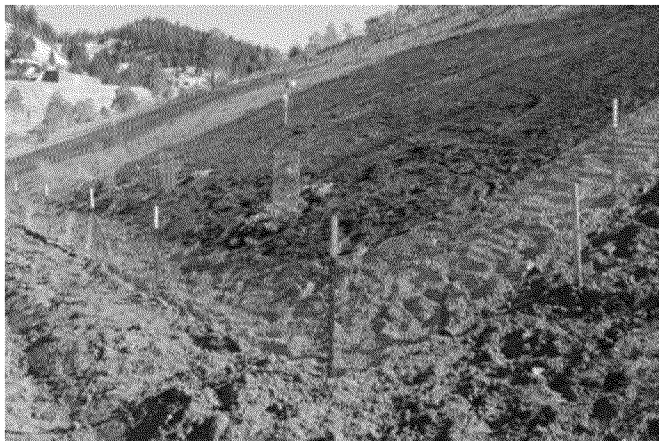
2016 Revegetation Treatability Study Investigation

Prepared three revegetation plots:

- ▶ Conducted initial soil sampling
- ▶ Performed deep lime/nutrient amendment incorporation
- ▶ Conducted post-amendment soil sampling
- ▶ Seeded and installed containerized plants
- ▶ Installed monitoring equipment with data loggers

Prepared three hydrology plots:

- ▶ De-vegetated half of the hydrology plot as a control
- ▶ Performed vegetation surveys
- ▶ Conducted initial soil sampling
- ▶ Installed monitoring equipment with data loggers

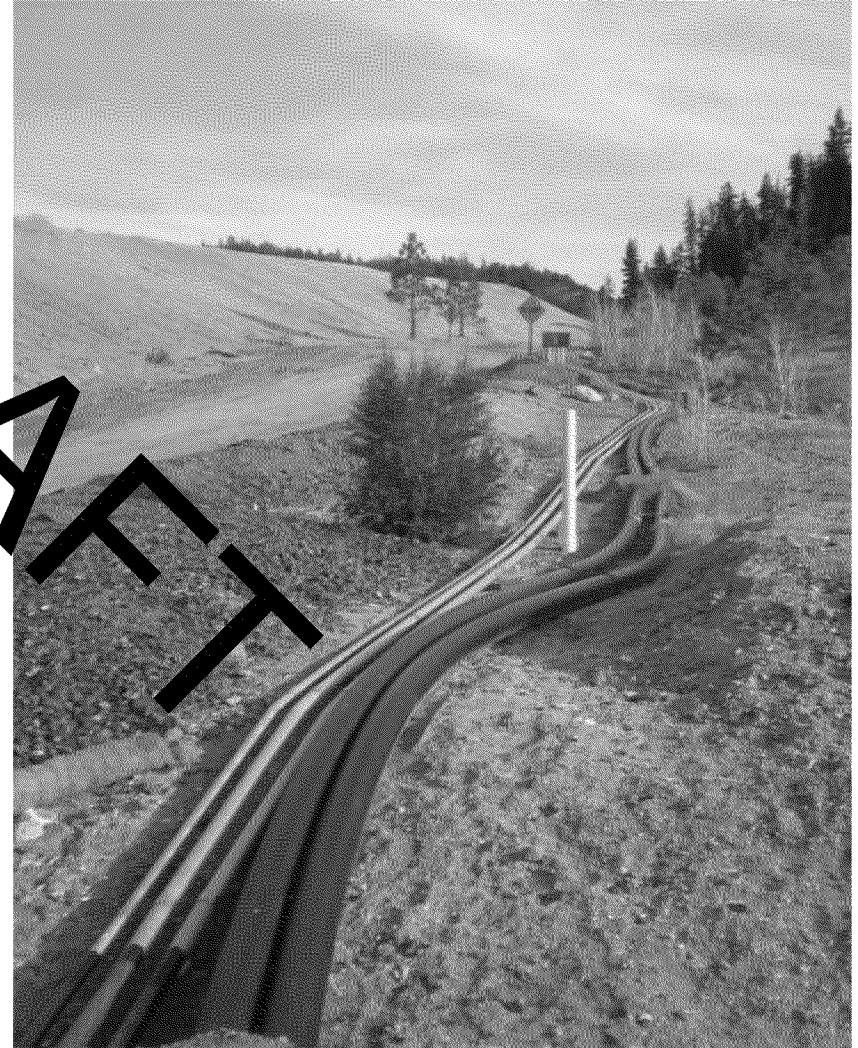
2016 Upper Pond Conveyance System Construction

Dual-Contained HDPE pipeline connecting Pond 1 and Pond 2 with Pond 4

- ▶ Above and underground sections complete
- ▶ Cross-over valves constructed

Pump Stations Constructed at Pond 1 and Pond 2

- ▶ Concrete pads constructed
- ▶ Electrical and communication panels installed
- ▶ Pumps installed

Access Road constructed at base of Pond 2 Slope
